REPORT NUMBER: NCAP-MGA-2006-012

**NEW CAR ASSESSMENT PROGRAM
FRONTAL BARRIER IMPACT TEST**

**GENERAL MOTORS DE MEXICO
2007 CHEVROLET SUBURBAN
NHTSA NUMBER: M70100**

**PREPARED BY:
MGA RESEARCH CORPORATION
5000 WARREN ROAD
BURLINGTON, WI 53105**

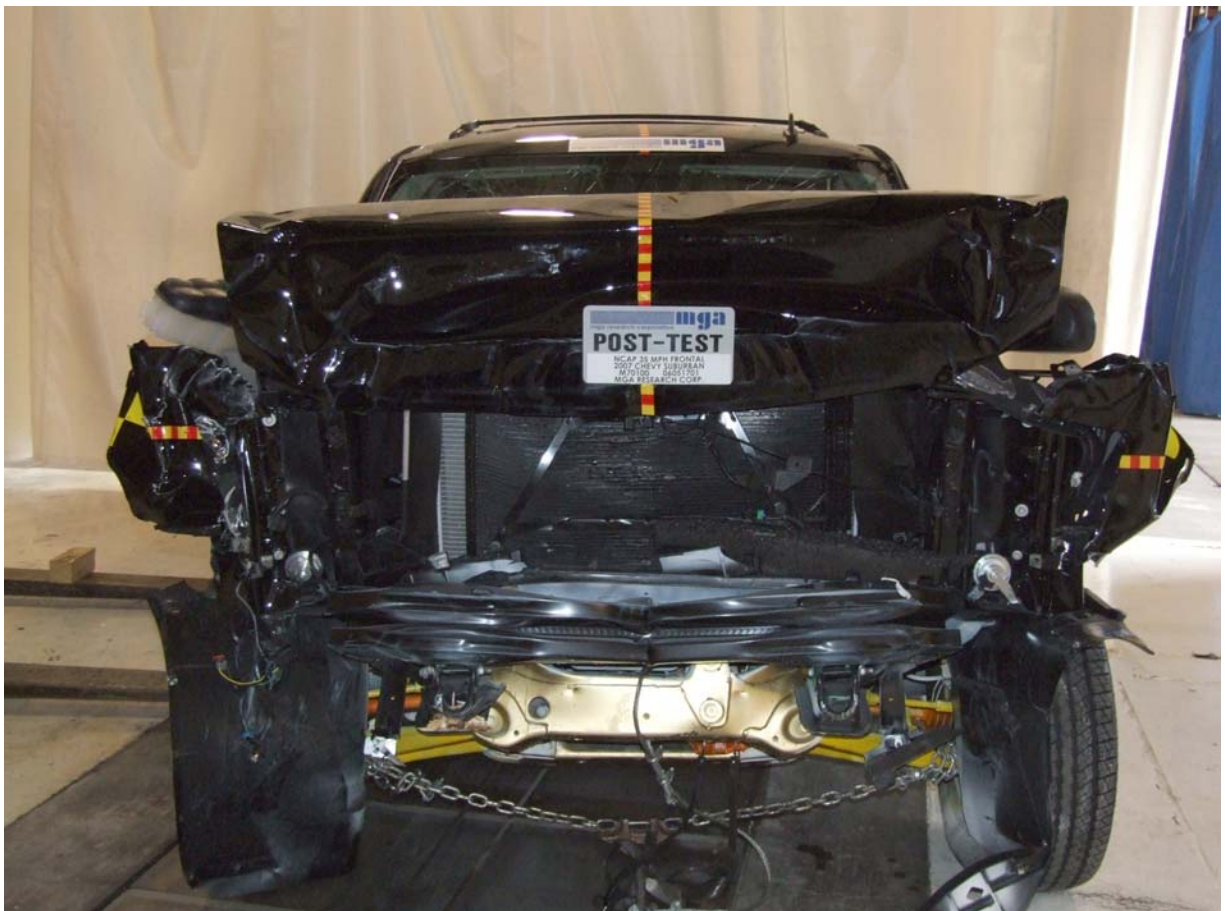
Post-Test Front View

The maximum static crush of the vehicle was 730 mm and both the driver and passenger side doors remained closed and latched during the impact event and were operable after the impact.

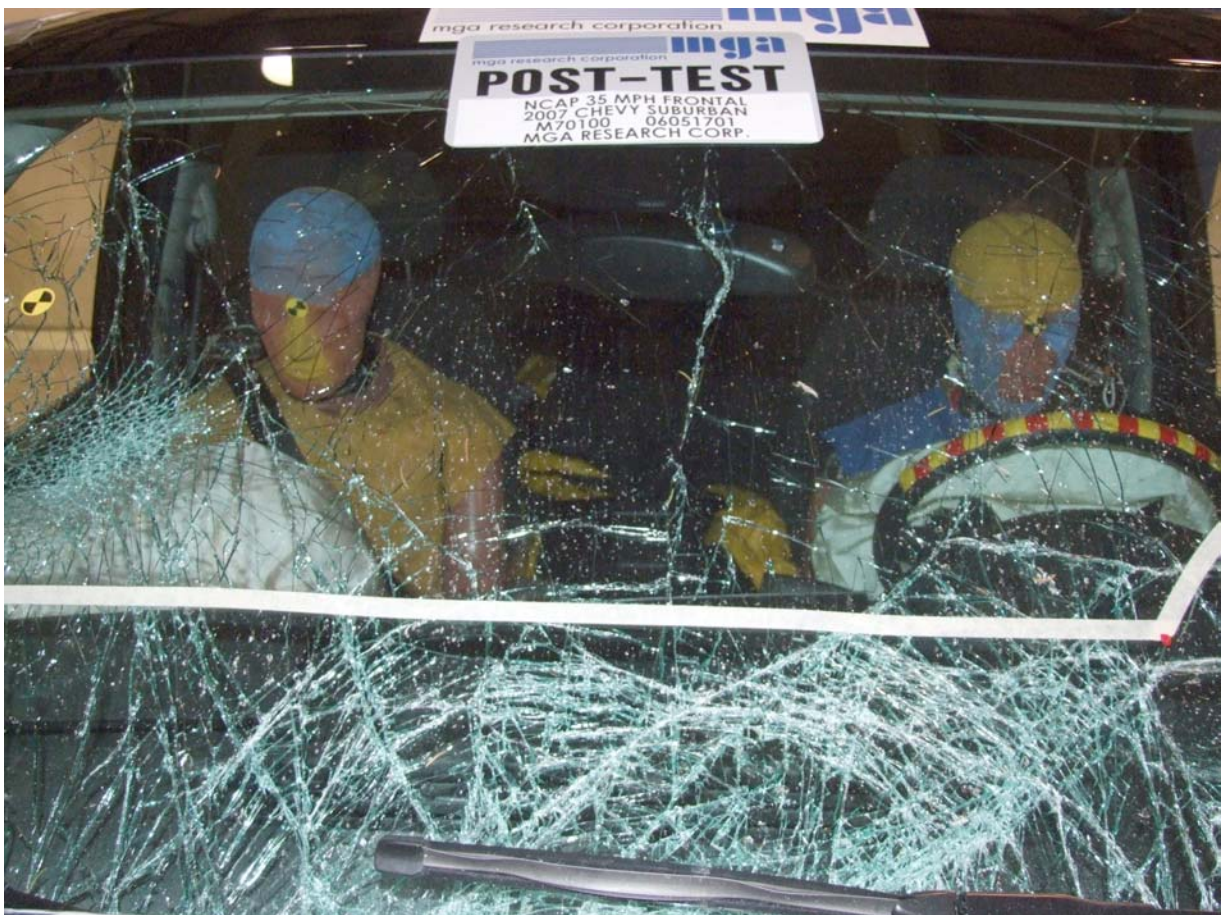
Post-Test Windshield View

There was 100 percent windshield retention and no intrusion into the protected zone of the windshield during the event. There was no Stoddard Solvent leakage after the event or during any phase of the static rollover.

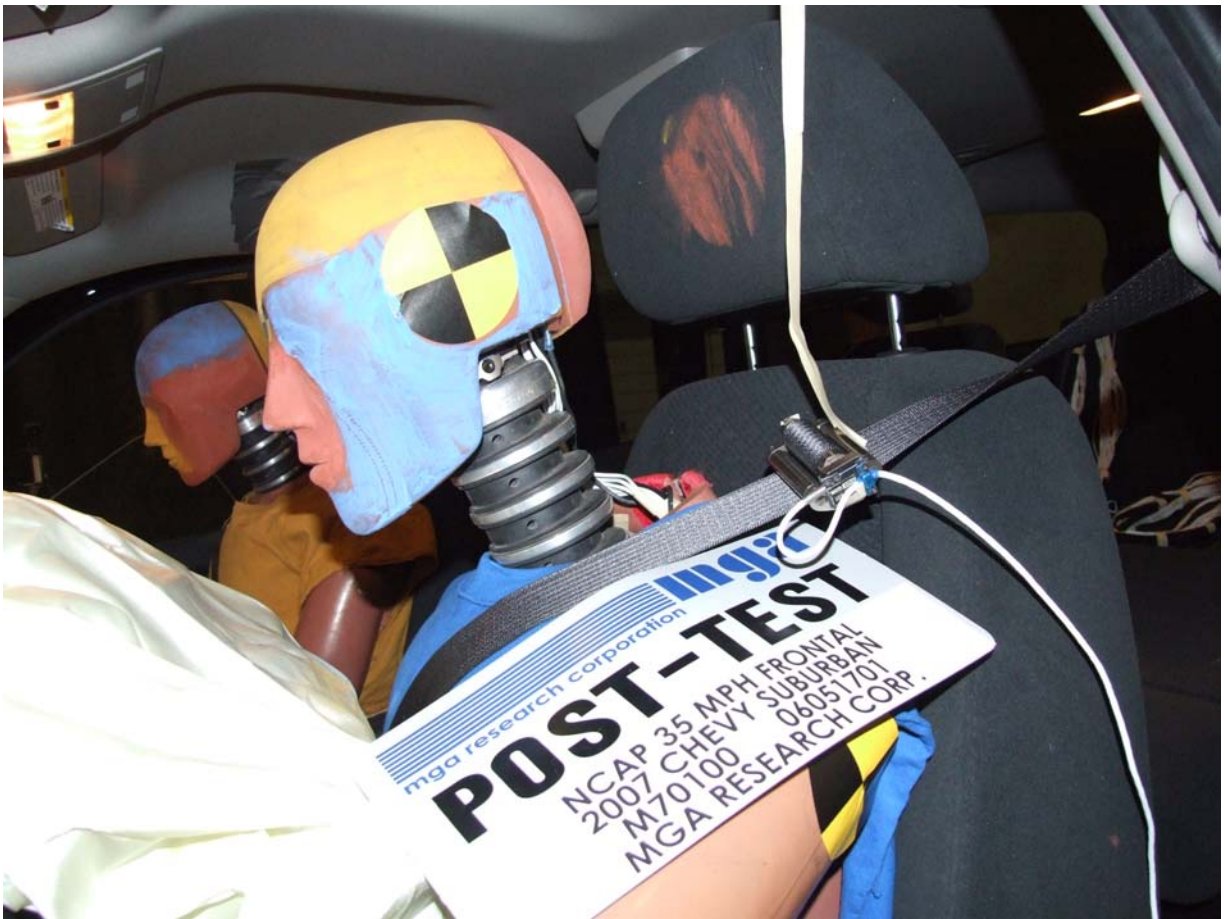
Post-Test Driver Dummy Head Contact

The driver's head and chest contacted the airbag. The driver's head also contacted the headrest. The driver's knees contacted the bolster. The passenger's head and chest contacted the airbag. The passenger's head also contacted the headrest. The passenger's knees contacted the glove box.

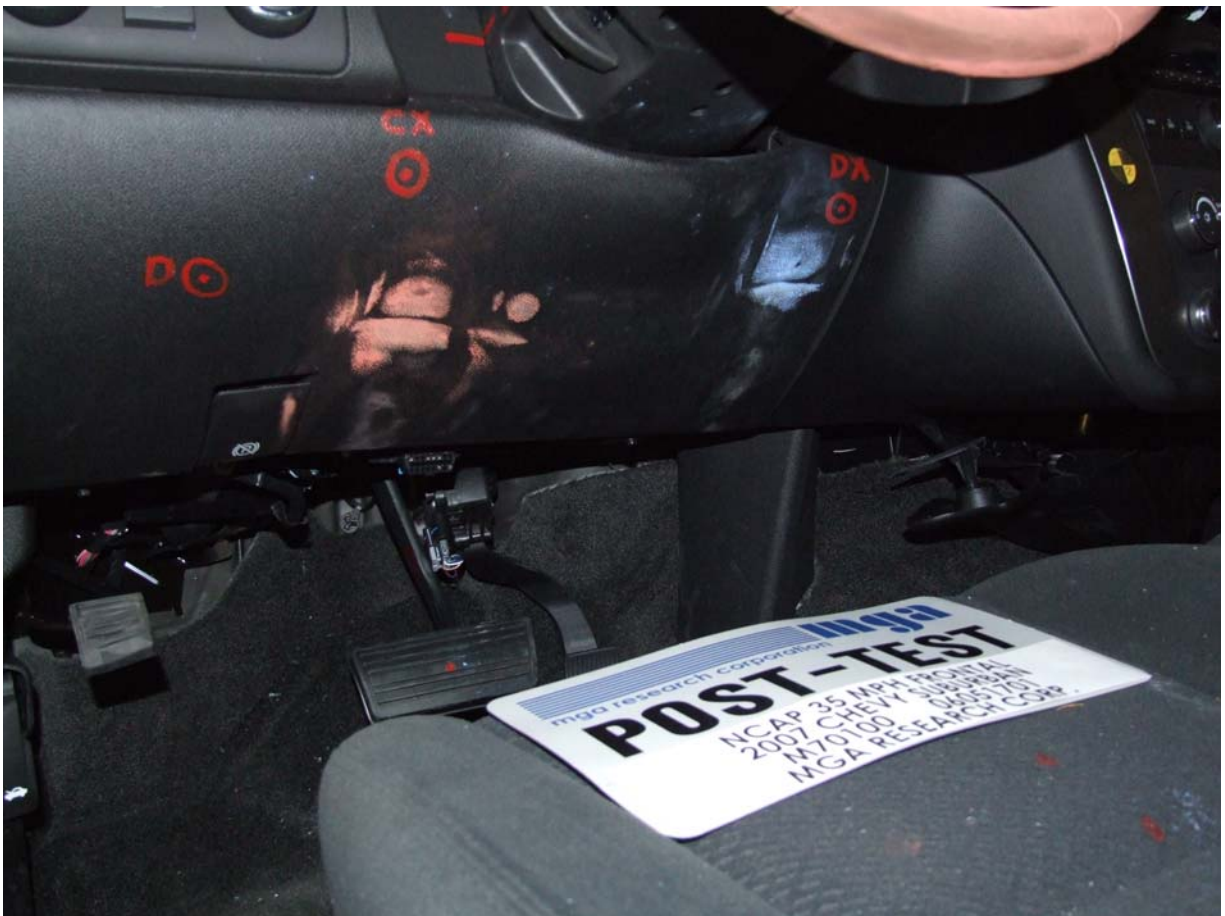
Post-Test Driver Dummy Knee Contact

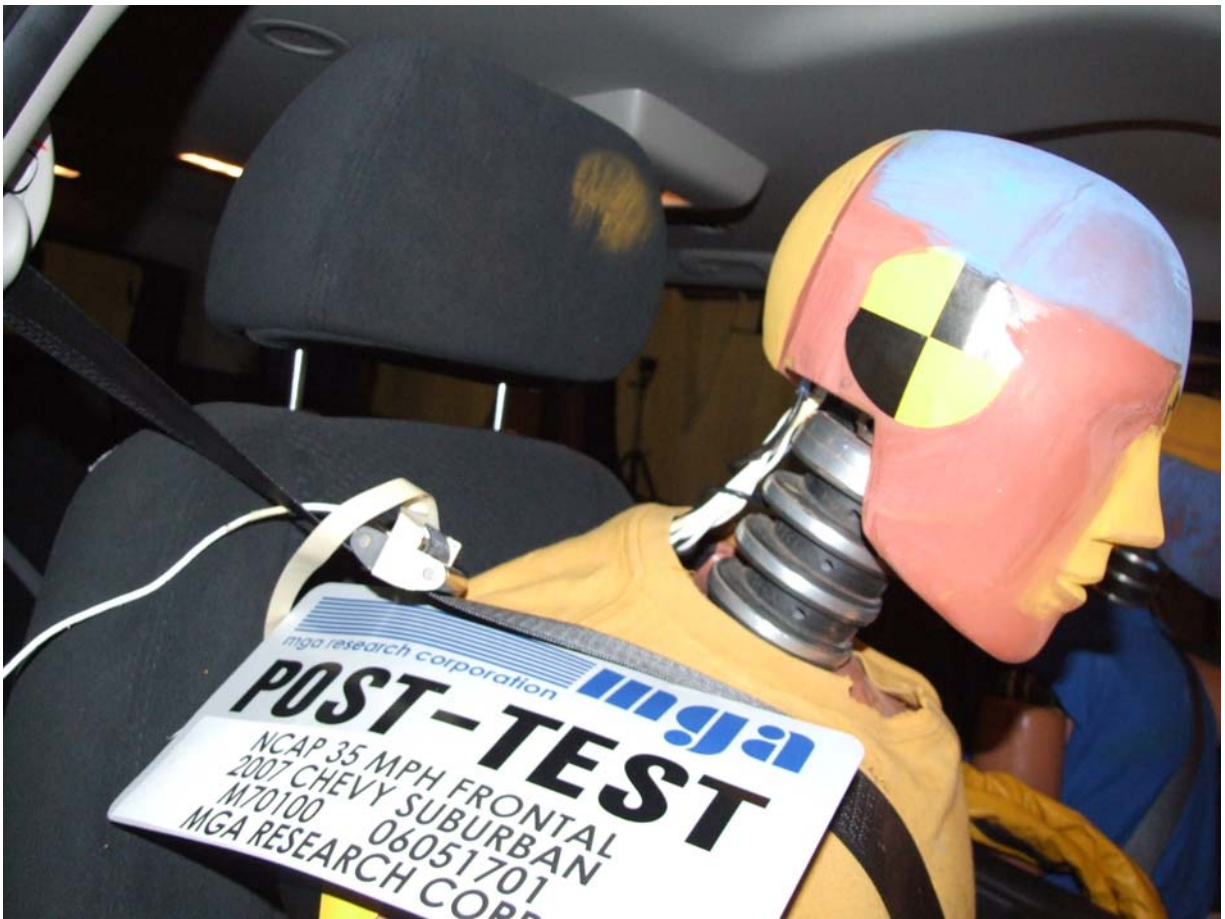
Post-Test Passenger Dummy Head Contact

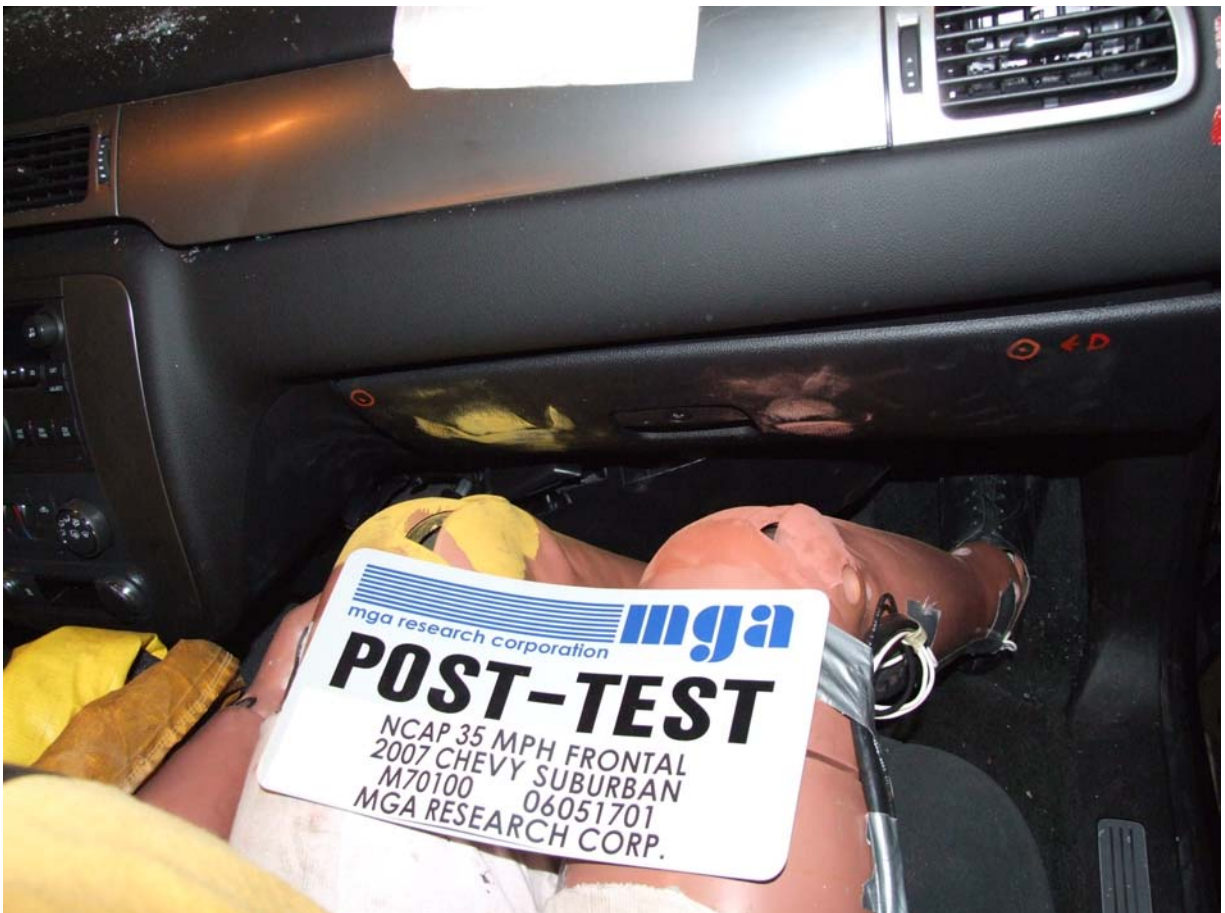
Post-Test Passenger Dummy Knee Contact

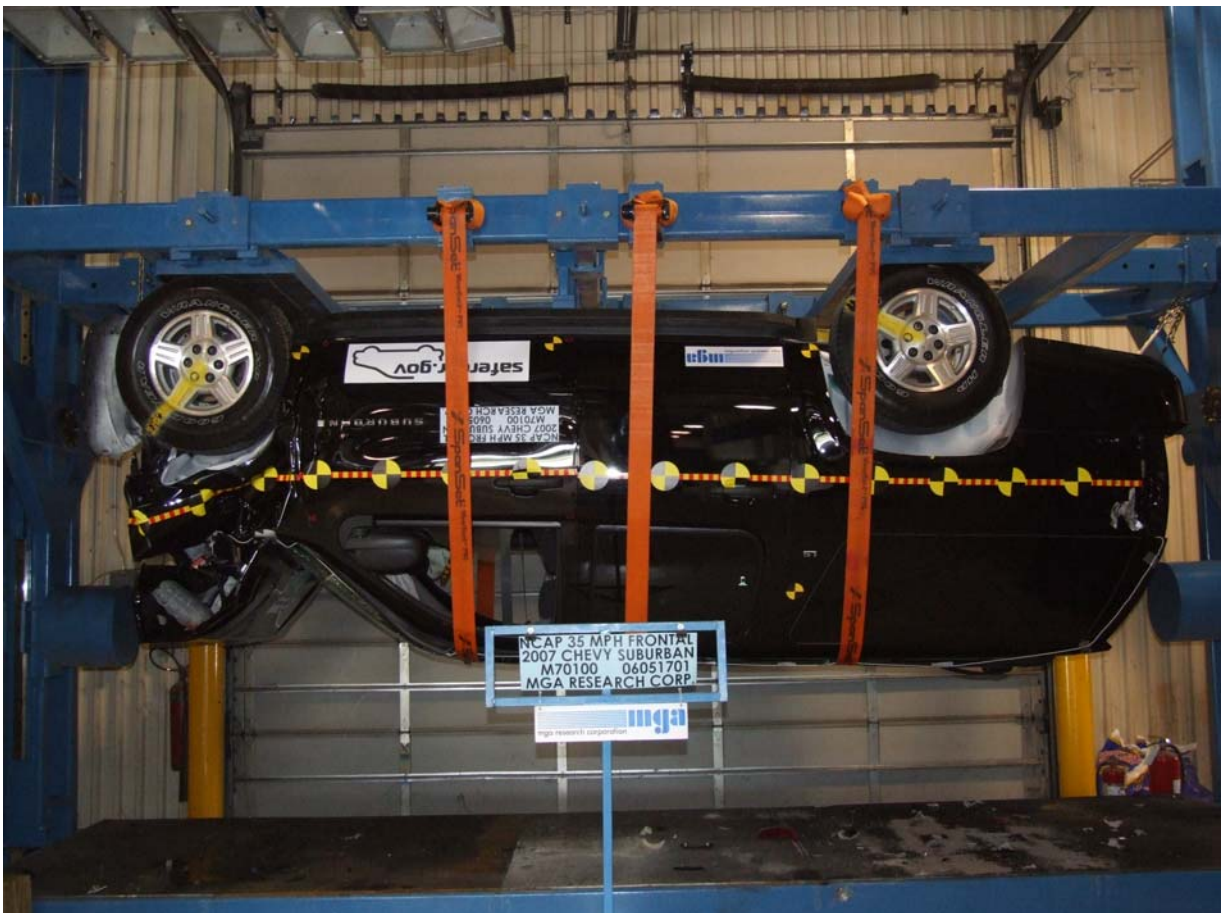
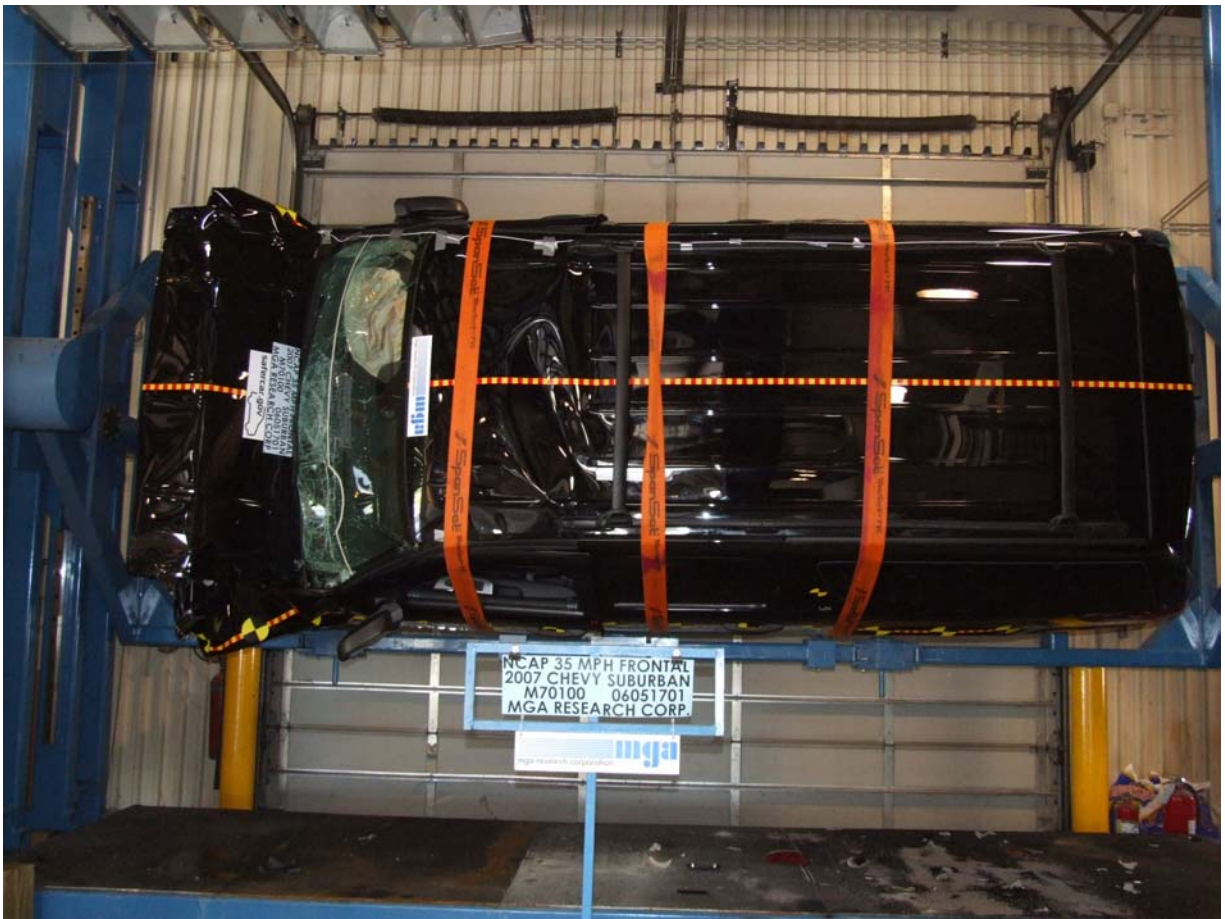
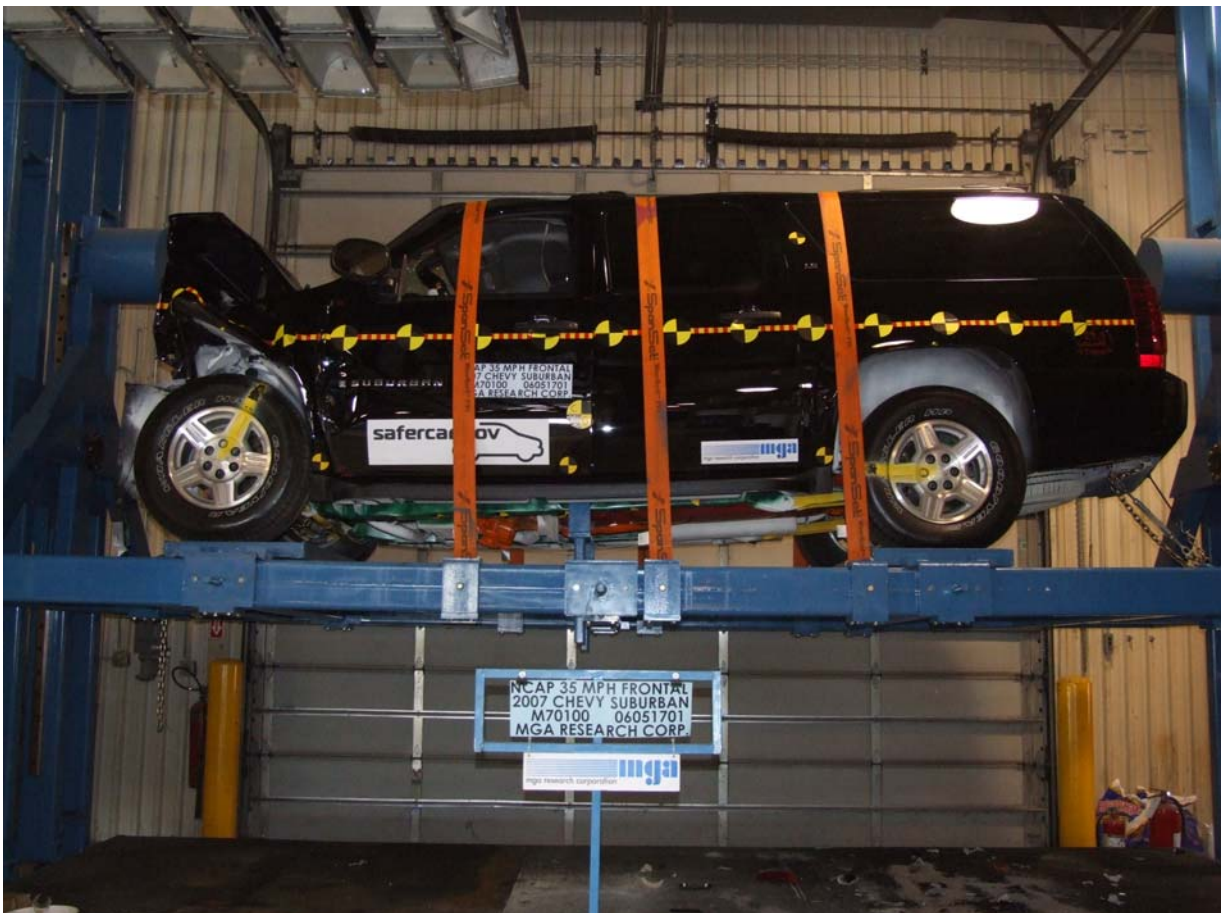
Vehicle on Rollover Device at 90 Degrees

Vehicle on Rollover Device at 180 Degrees

Vehicle on Rollover Device at 270 Degrees

Vehicle on Rollover Device at 360 Degrees

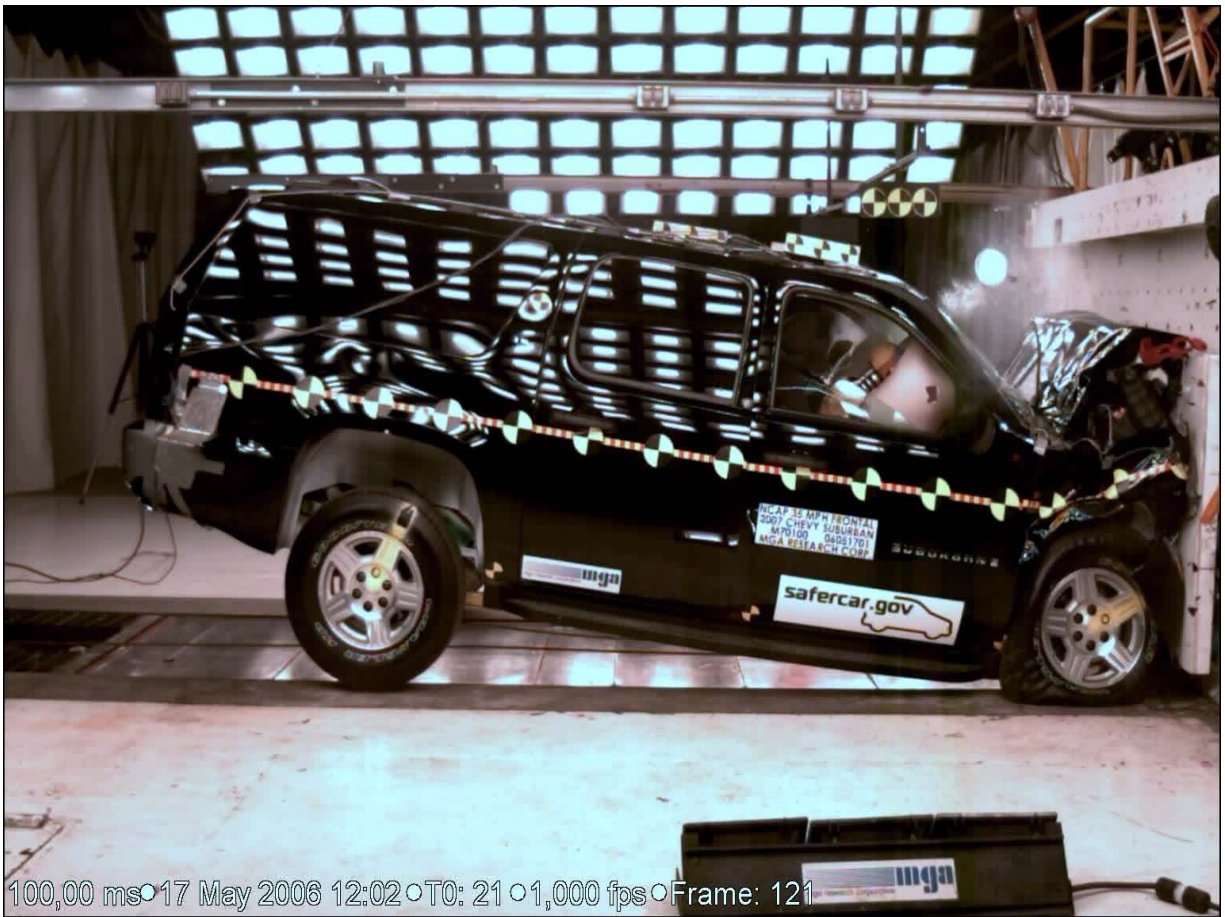
Vehicle Impact

A load cell barrier was impacted by a 2007 Chevrolet Suburban at a velocity of 56.3 kph. The test was performed at MGA Research Corporation on May 17, 2006. Pre-and post-test photographs of the vehicle and dummies can be found in Appendix A.
